Manhole Inspection Summary

Manhole # S02AA2011MH

Insp Date: **8/3/06 7:19 AM**

Location Address: **3415 BANCROFT RD**

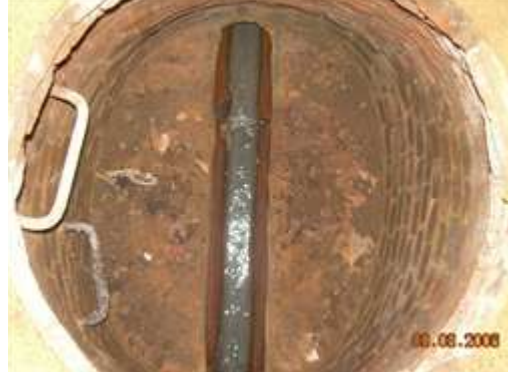
Top View

Corroded steps. Adjustment and Corbel infiltration. Evidence of surcharge - Bench debris.

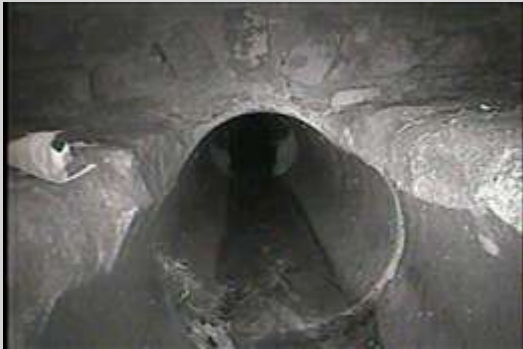
8 in. Circular Gravity Sewer Pipe Out @ 12 O'Clock

Channel root intrusion.

Infiltration: **Evidence** Pipe Seal Cond: **Unknown**

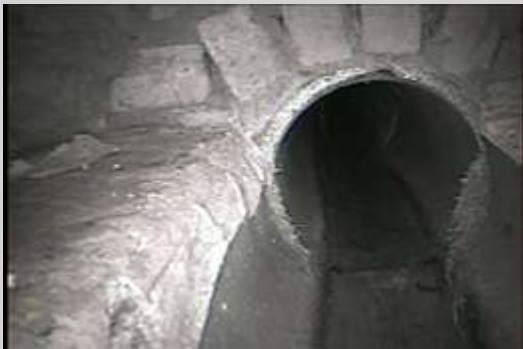
8 in. Circular Gravity Sewer Pipe In @ 6 O'Clock

Infiltration: **Evidence** Pipe Seal Cond: **Roots**
